**DATE:** July 26, 2006

**FROM:** Scott R. Wheaton, Watershed Scientist  
Watershed Management Services

**SUBJECT:** Legacy Pointe Subdivision (Forest Heights LLC) Watercourses

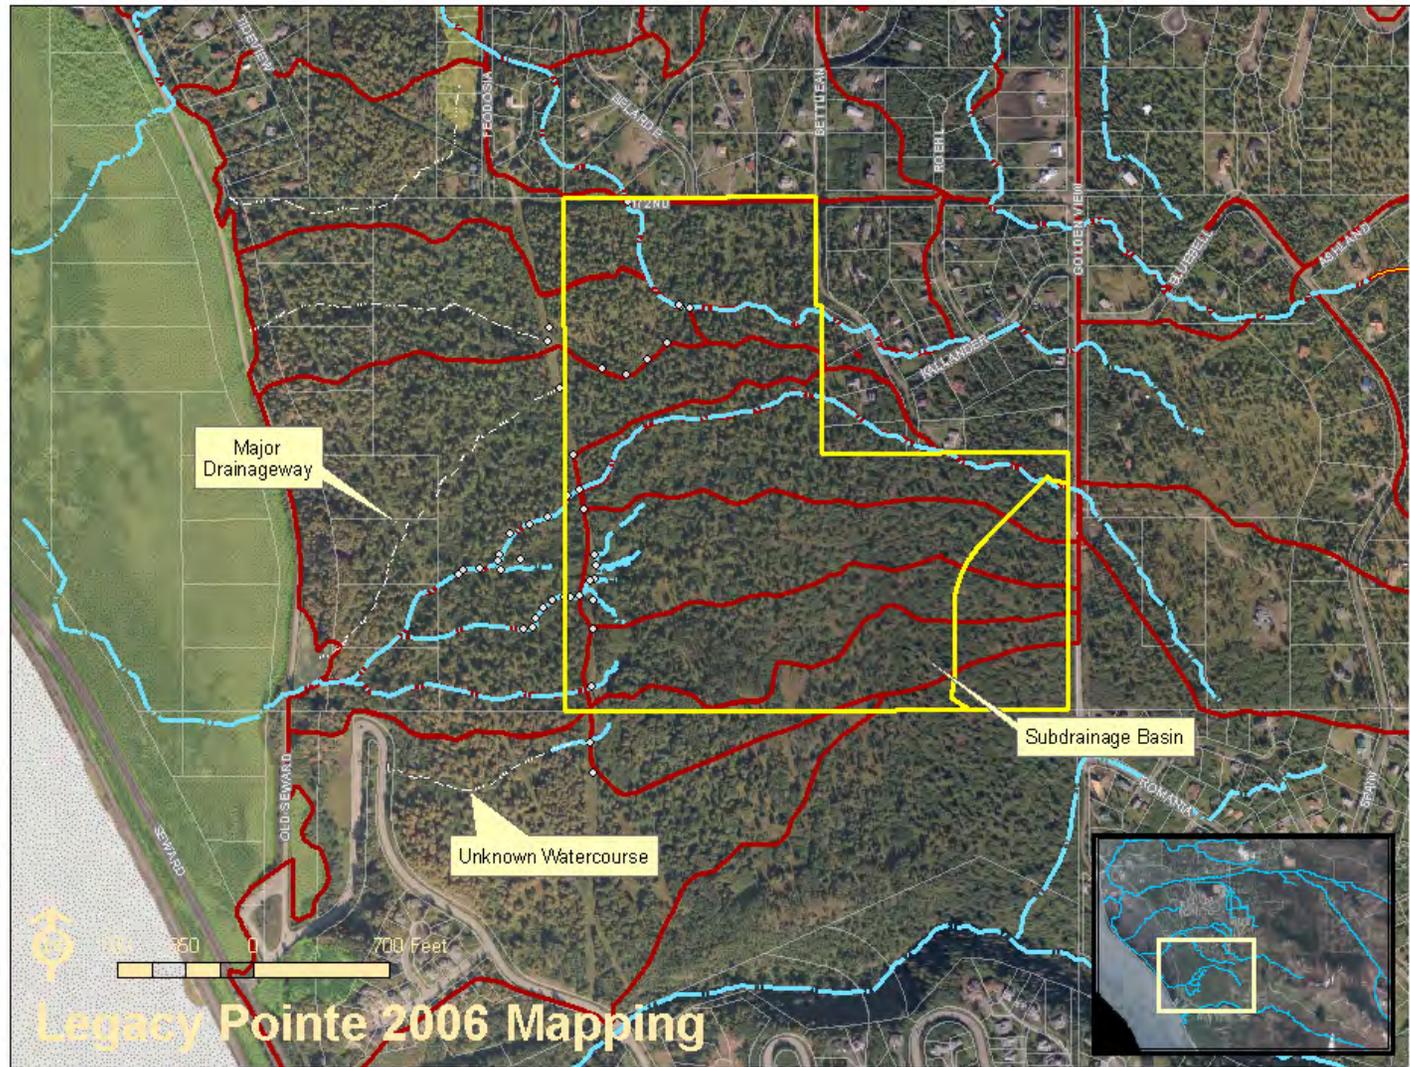
Figure 1: Legacy Pointe (Forest Heights LLC) Vicinity

Natural drainage across Legacy Pointe is divergent, spreading out runoff from this area across a large downstream drainage area (Figure 1). Development (including construction of roads

typically across the fall line) will tend to concentrate runoff and focus it to fewer subdrainage basins. Careful consideration should be given to how runoff flows are combined to avoid intensification of downstream impacts or focus of flows into more sensitive drainages.

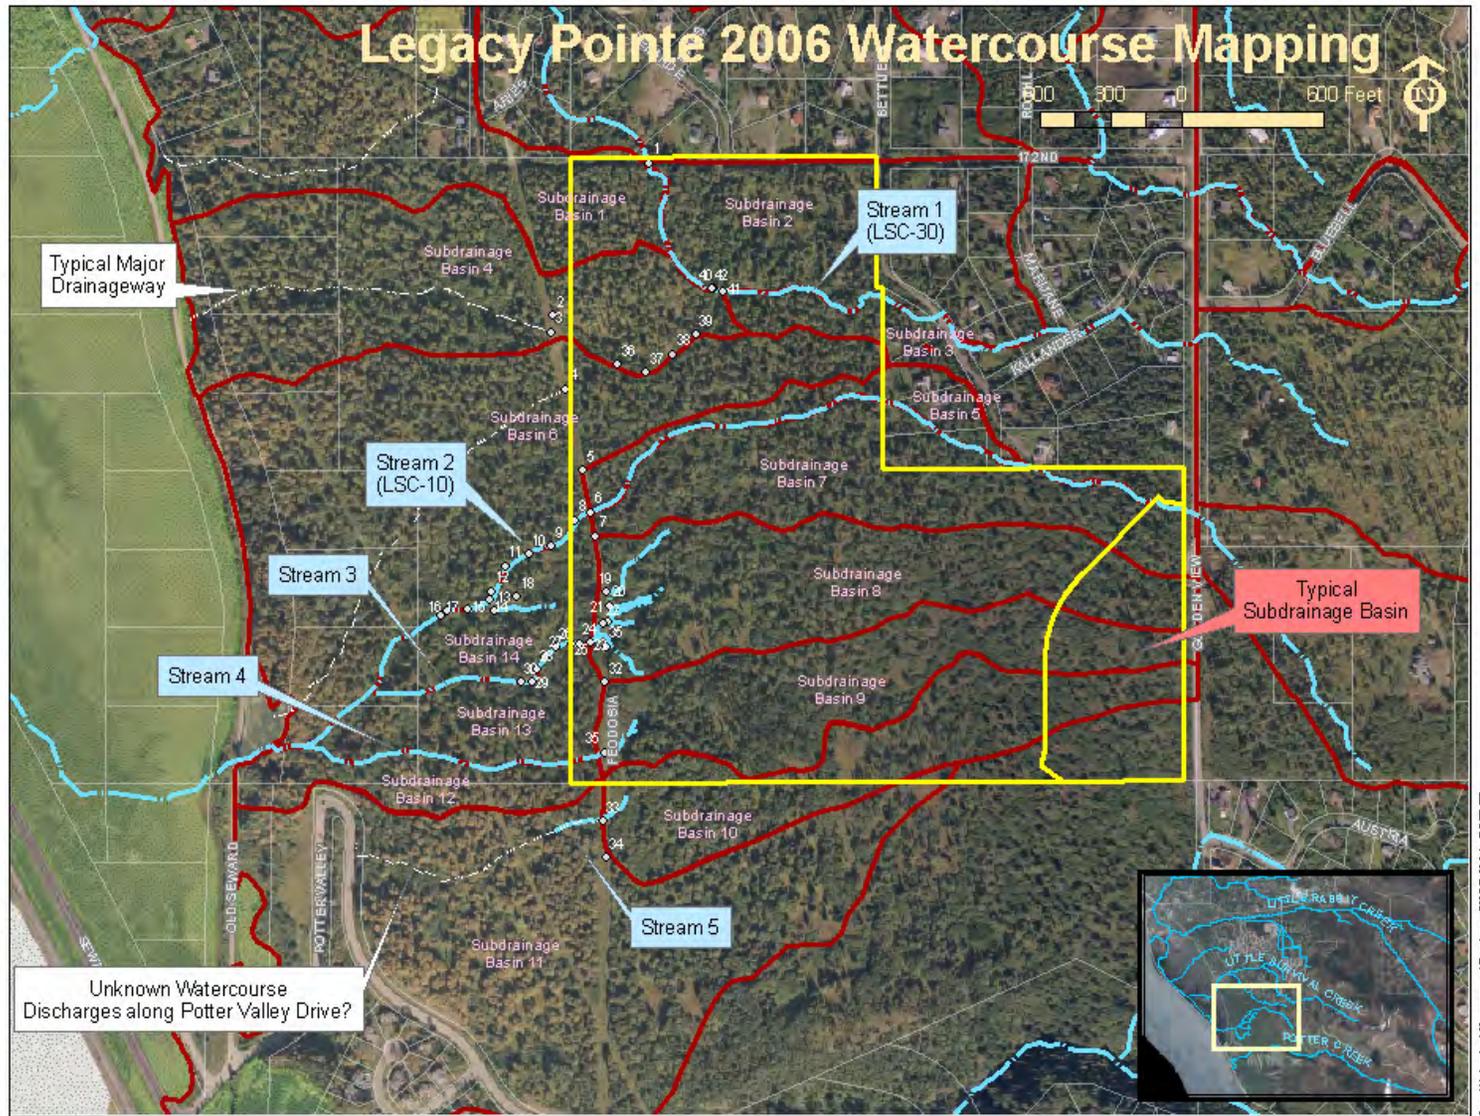
Figure 2: Legacy Pointe (Forest Heights LLC) Watercourses

Current mapping identified five primary stream features and four major drainageways exiting the Legacy Pointe parcel, all draining to Potter Marsh receiving waters (Figure 2). Despite the single receiving water (Potter Marsh), in general, the drainage off Legacy Pointe is divergent—the surface is broadly convex and drainage tends to radiate outward. This is exemplified by the fact that LSC-30, the northernmost stream feature, drains to the mainstem of Little Survival Creek to the north, while the southern most watercourse draining Legacy Pointe (stream 5 in figure 2) drains across Potter Valley Drive. Across Legacy Pointe itself this divergent character

is reflected in many, relatively narrow and long subdrainage basins aligned along the radial fall lines (i.e., subdrainage basins 1, and 4 through 10 in Figures 1 and 2).

Subdrainage basins 10 and 11 and the southernmost watercourse/stream feature exiting Legacy Pointe (stream 5) appear to drain to the ditch along Potter Valley Drive (location of this drainage will be confirmed this late fall or next early spring). In addition to the potential impacts identified above, inadequately controlled post-development peak flows directed through this drainage system could also significantly impact Potter Valley Drive drainage and road systems through erosion, sedimentation and icing problems. (Also note that in order to divert flows directly to Potter Creek, the discharge point from Legacy Pointe would have to be located about 1500 feet above the western boundary of the subdivision or diversion ditching would have to be constructed outside the property boundaries.)

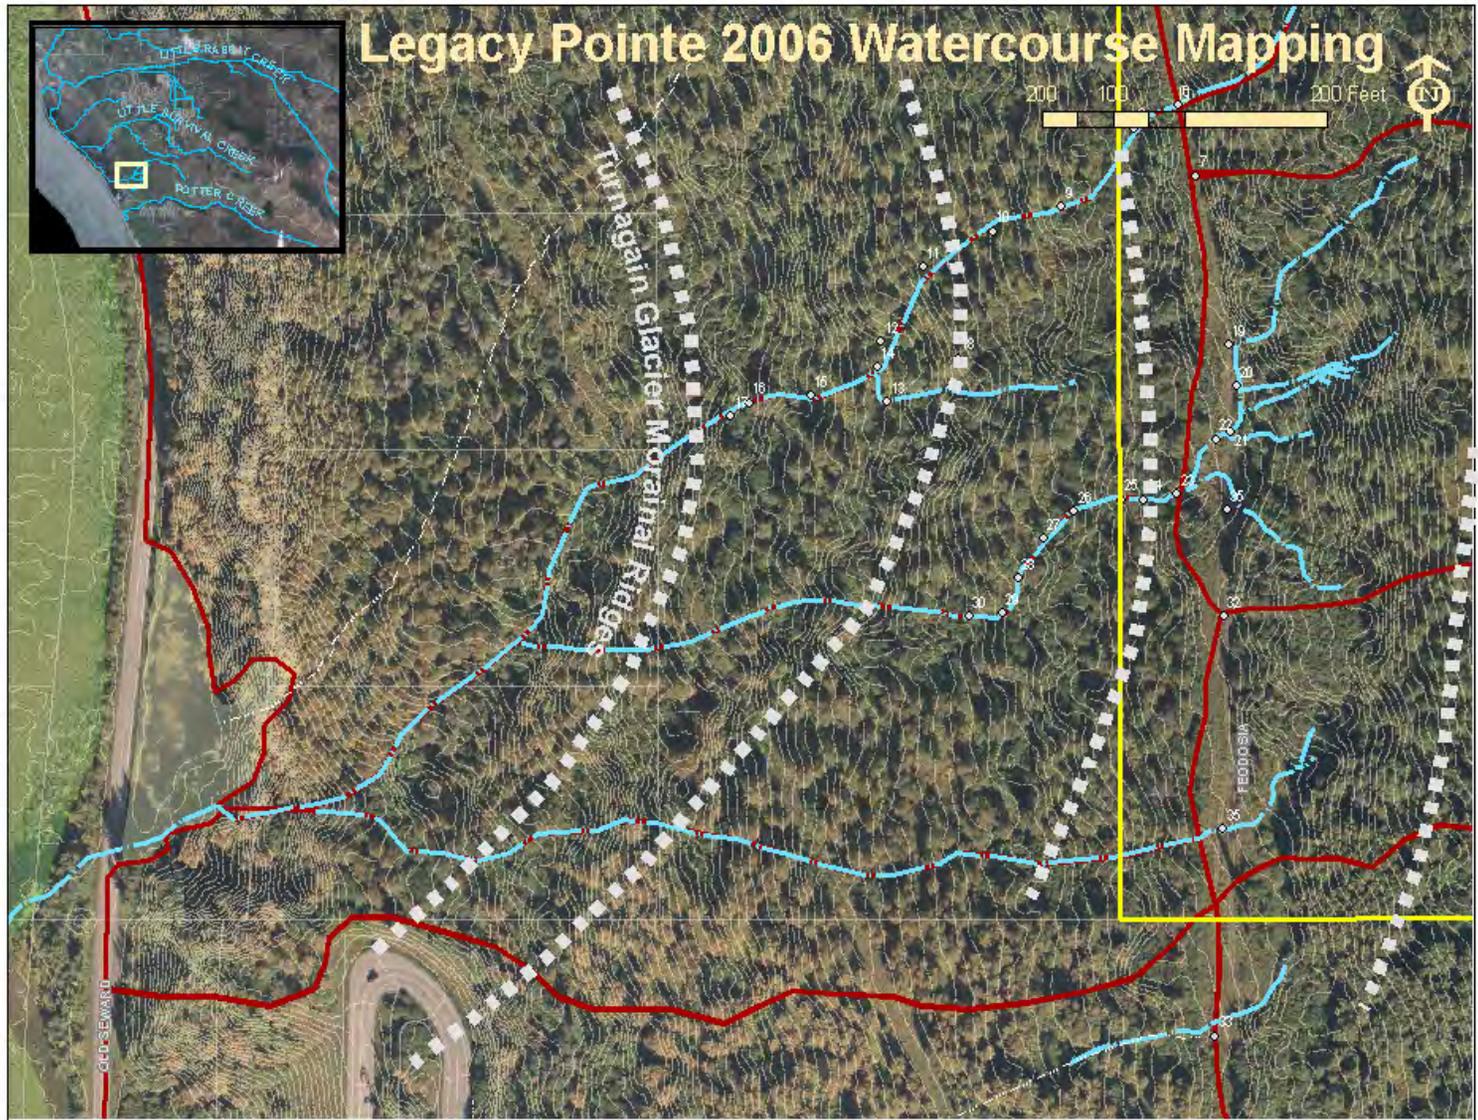
Figure 3: Legacy Pointe (Forest Heights LLC) Drainage Pattern

Downstream drainages cross a series of steep morainal ridges (Figure 3). Increased post-development peak flows directed across the steep faces of these ridges could dramatically increase erosion and associated sedimentation along the ridge surfaces and into Potter Marsh.
