Site Conditions and Summary of Previous Studies

HLB Parcel 2-156 (“Legacy Pointe tract B2”) is a 9.6 acre parcel, currently zoned as PLI (Public Lands and Institutions), which is suitable for use as a cemetery. Access to the property is via Golden View Drive, which runs along the length of the eastern property line. Vacant land surrounds all other sides of the parcel.

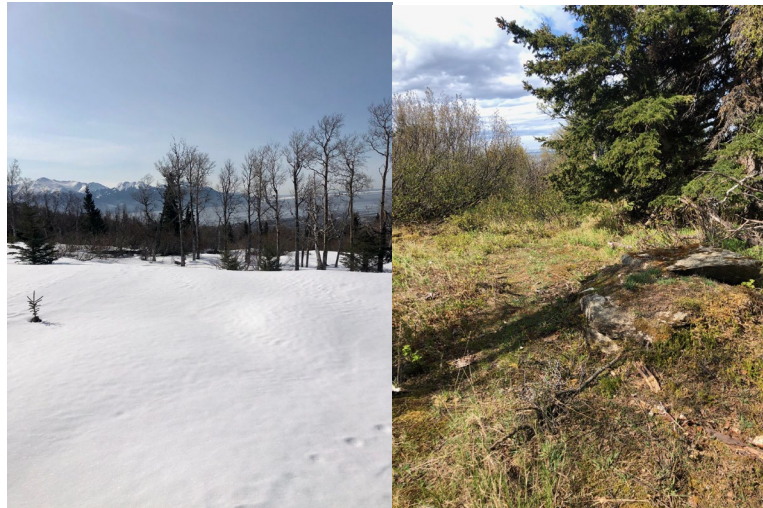
Photo: Winter and spring at Parcel 2-156

The parcel slopes downhill from Golden View Drive (between 1% to 18% slope, or maximum grade of 10.2°), with the steepest areas along the southern border of the property. The property features scenic vistas from many points overlooking Potter Marsh, Cook Inlet, and the Anchorage skyline.

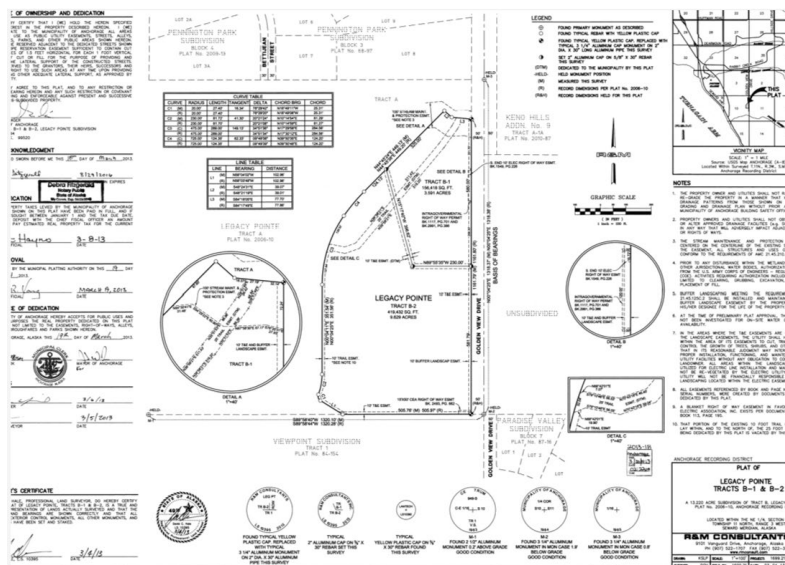
Figure: Survey of Parcel 2-156 from 2013

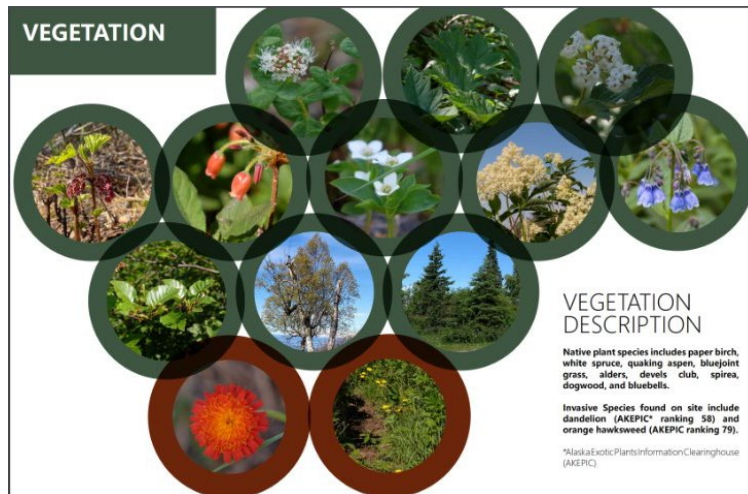
Figure: Existing conditions - vegetation

property, and land cover is primarily composed of deciduous forest with pockets of white and black spruce, low shrub, and tall shrub.¹

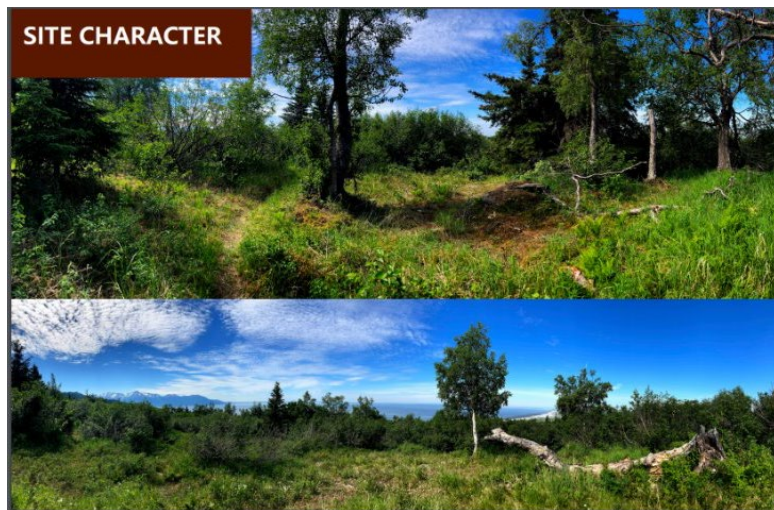
The parcel is currently accessed by neighborhood residents for recreational purposes. Approximately 350 feet of the historic Moen Trail, which has been identified in USGS maps since the 1950s, transects the northern portion of the property. The parcel is contiguous with approximately 300 acres of undeveloped land that will become the Potter Marsh Watershed Park. Also adjacent is approximately 3.6 acres of vacant land owned by Anchorage Water and Wastewater Utility.

Photo: Existing conditions - site character and social trails

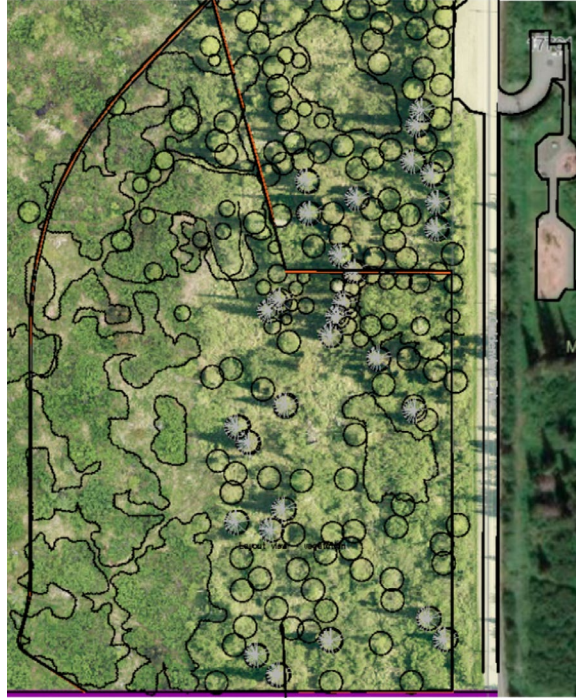
Figure: Existing conditions - vegetation varies from east-to-west

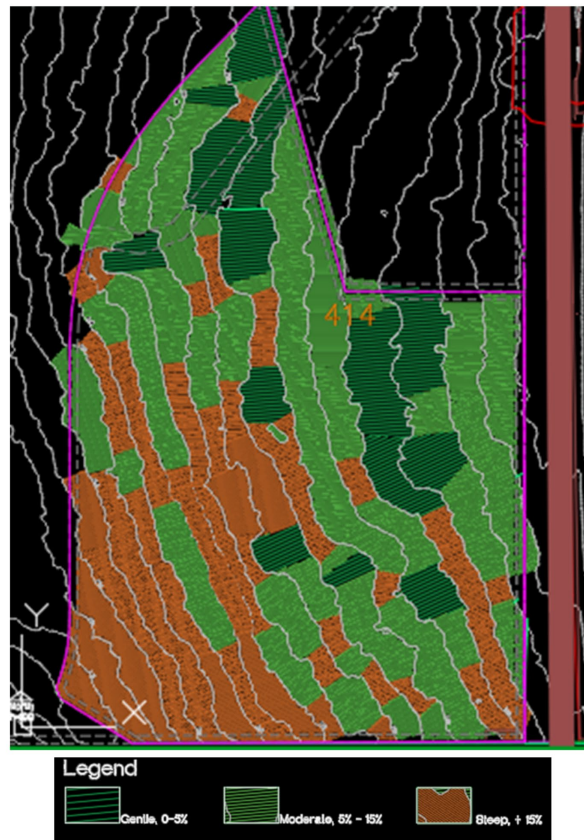
Figure: Slopes vary from 0% - 18%

HLB Parcel 2-156 is 9.6 acres. Of this, 0.95 acres are in easements and 3.43 acres have slopes in the 13%-18% range (not ideal for the interment of casketed or shrouded remains).

The site has 5.24 acres of land with slopes of 0%-12%. We're intentionally limiting our maximum burial density to 400 per acre¹³ so the site has the capacity for no more than 2,098 interments of casketed or shrouded remains.

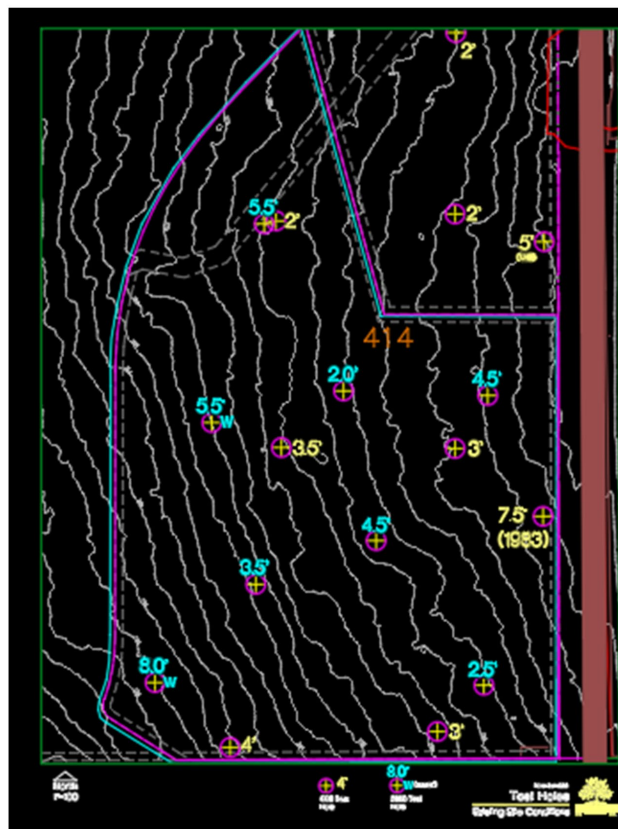
Figure: Depth to bedrock (and water)

Prior studies featuring test pits demonstrate that there are occasional areas where shallow bedrock is encountered. Test pits along the south portion of Golden View Drive encounter high density cobble at depths of 5 to 7.5 feet. Many pits were dug to depths of 15 feet without encountering bedrock. The September 2025 Geotech investigation added 8 test pits. Pits terminated at bedrock anywhere from 2' to 8'. **The shallowest of the three test pits were TP 5 (2.5'), TP 7 (2'), TP 8 (3.5')²**

Water was encountered in TP3 (at 5.5'), and TP 4 (at 8'). "Water was observed as seepage into the bottom of the test pits during excavation"⁶⁷

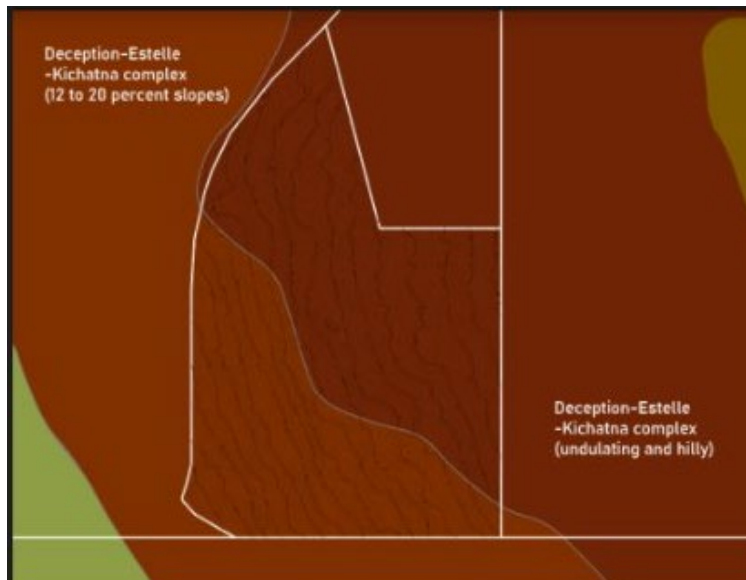
Figure: Existing conditions - soils description⁵

Excluding wetlands, soils were classified as well-draining. Key surficial geology identified within Parcel 2-156 includes morainal deposits (primarily glacial till) consisting of intermixed gravel, sand, silt, and clay.³ In the fall of 2025, R&M generally described the site's soils as "moist to wet" though TP2 and TP3 had a dry layer of poorly graded sand under soil.⁴

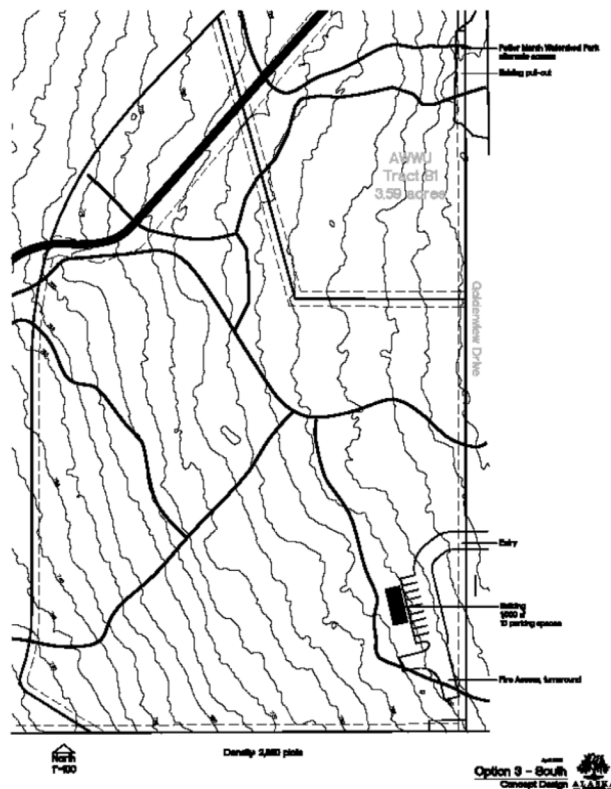
Figure: Working concept plan 2026

We plan to construct a modest structure to house staff offices and provide a family reception area, with an attached or detached structure for housing interment equipment and other maintenance supplies. A driveway and small parking area will be installed to provide access for staff and patrons

from Golden View Drive. The number of parking spaces is yet to be determined.¹² Permeable surface driveways, parking areas, and walkways will be installed using GeoBlock (or a similar product) if feasible to minimize impact to existing drainage patterns.

In preliminary mapping of potential grave sites (avoiding areas sloped >12%), we estimate 1,180 sites can be configured along the existing trail system. Development of proposed secondary trails increases trailside capacity to 2,240 plots (exceeding our planned burial density). If interments were permitted off the trail systems, then the potential capacity would be 2,550 plots (again, exceeding our planned burial density).
